DEPARTMENT OF TRANSPORTATION**DIVISION OF ENGINEERING SERVICES**

Contract #: 04-0120F4Cty: SF/ALA Rte: 80 PM: 13.2/13.9File #: 1.28**WELDING INSPECTION REPORT****Resident Engineer:**Siegenthaler, Peter**Address:** 333 Burma Road**City:** Oakland, CA 94607**Report No:** WIR-025218**Date Inspected:** 16-Jul-2011**Project Name:** SAS Superstructure**OSM Arrival Time:** 900**Prime Contractor:** American Bridge/Fluor Enterprises, a JV**OSM Departure Time:** 1730**Contractor:** American Bridge/Fluor Enterprises, a JV**Location:** Job Site**CWI Name:** See Below**CWI Present:** Yes No**Inspected CWI report:** Yes No N/A**Rod Oven in Use:** Yes No N/A**Electrode to specification:** Yes No N/A**Weld Procedures Followed:** Yes No N/A**Qualified Welders:** Yes No N/A**Verified Joint Fit-up:** Yes No N/A**Approved Drawings:** Yes No N/A**Approved WPS:** Yes No N/A**Delayed / Cancelled:** Yes No N/A**Bridge No:** 34-0006**Component:** Orthotropic Box Girder**Summary of Items Observed:**

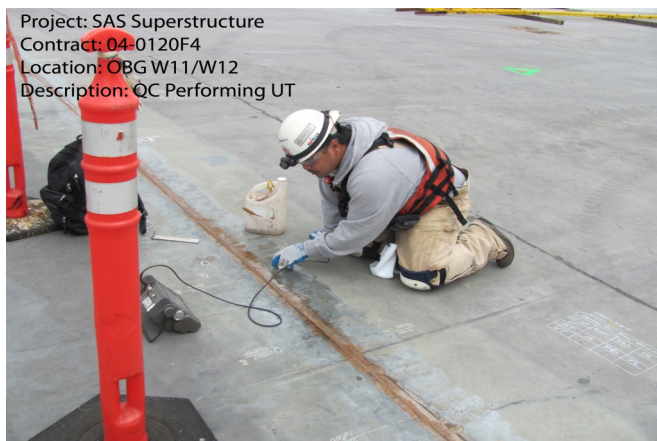
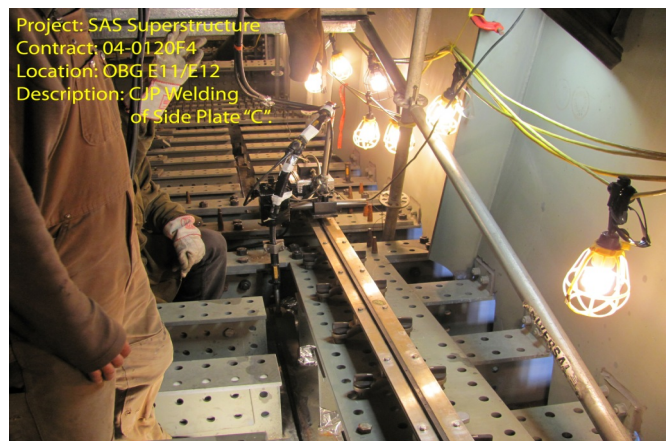
The welding was performed in the vertical (3G) position with work elevated at an approximate 22 degree incline utilizing the E71T-1 consumable. The welding parameters and surface temperatures were verified by the QC inspector's utilizing a Fluke 337 clamp meter to measure the electrical welding parameters and Tempil Heat Indicators for verifying the preheat and interpass temperatures. At the time of the observation no issues were noted by the QAI.

The digital photographs below illustrate some of the work observed during this scheduled work date.
